3 WEST OF US 83 NORTH

IDENTIFICATION	
(1) State Names	North Dakota
(8) Structure Number	0094-156.609
(5) Inventory Route	00094
(2) Highway Agency District	61
(3) County Code	Morton, North Dakota

(4) Place Code	7200
(6) Features Intersected	MISSOURI RIVER
(7) Facility Carried	INTERSTATE 94
(9) Location	3 WEST OF US 83 NORTH
(11) Mile Point	156.576 mi

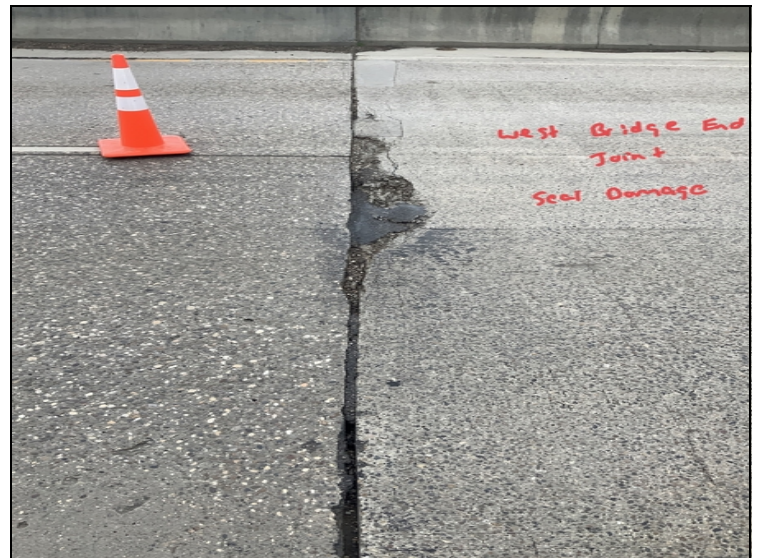
All Pourable Joint Sealant with seal damage with complete removal of sealant. . See Photos. 10August2020

Facing North and Downward. EB I-94 West End Bridge Joint with Seal Damage

Recommendation to Clean and reseal joints.

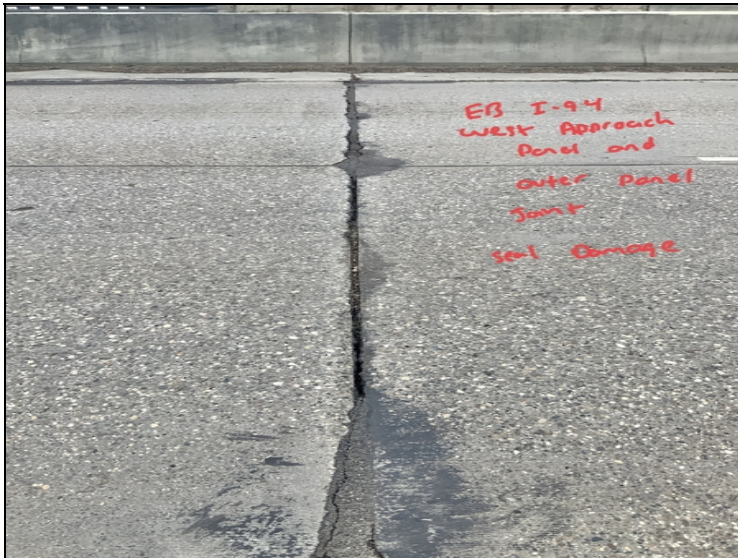
Facing North and Downward. EB I-94 West Approach and Outer Approach Transverse Joint Sealant Damage.

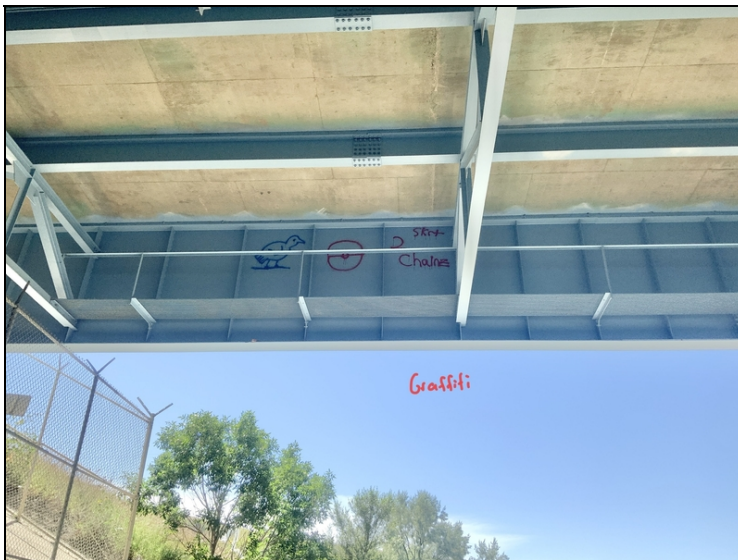
Facing South and Upwards. Graffiti applied to North Facia of EB I-94 Girder 2 in Span 7.

Recommendation to remove graffiti.

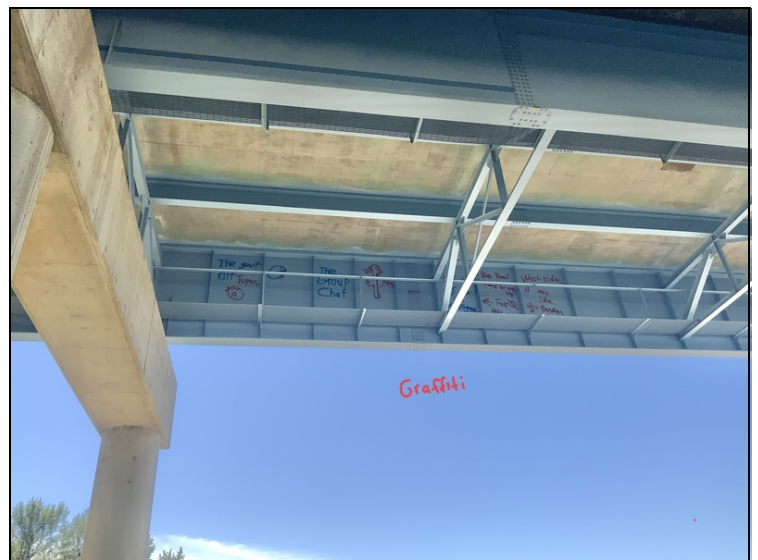
Facing South and Upwards. Graffiti applied to North web of Girder 4 in Span 6 West of Pier 7.

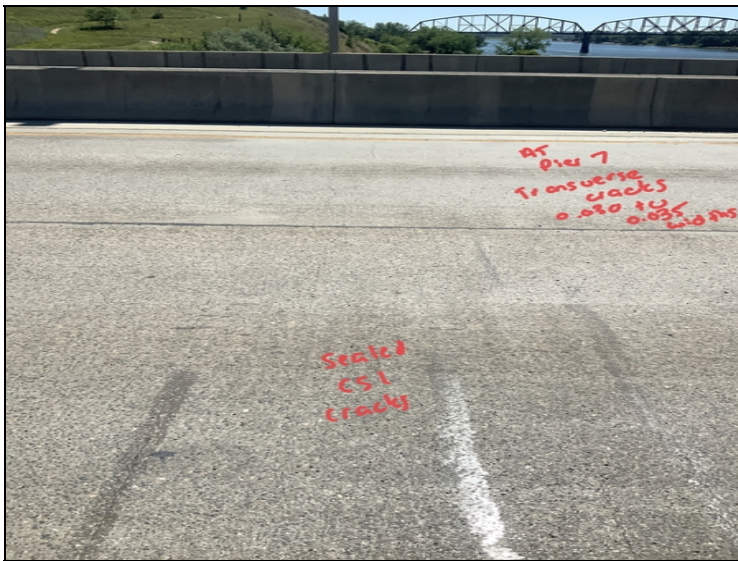
Various Transverse cracks Unsealed in the Wearing Surface and Barrier, Mainly in the WB and EB Passing Lanes with some in the Driving Lanes. 11August2020

Facing South, WB DL with sealed cracks, WB PL with transverse cracks at Pier 7.

Recommendation to Seal Wearing Surface and Barrier Cracks with approved material from Maintenance Manual. See Photos.

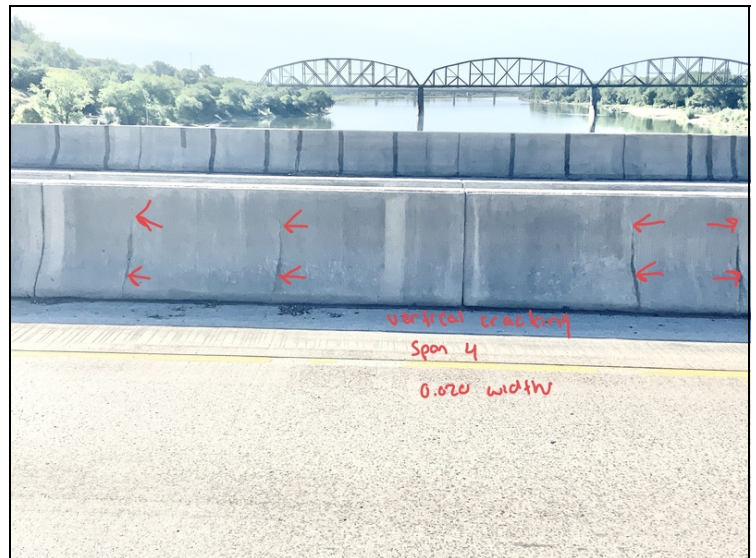
Facing South. Another View of Unsealed Vertical Cracks to South Barrier in Span 4.

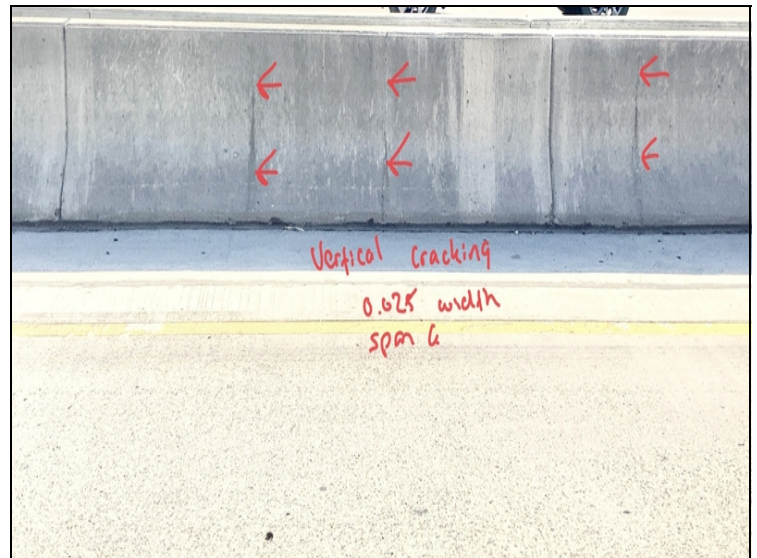
Facing South. Vertical Unsealed Cracks to South Barrier in Span 6.

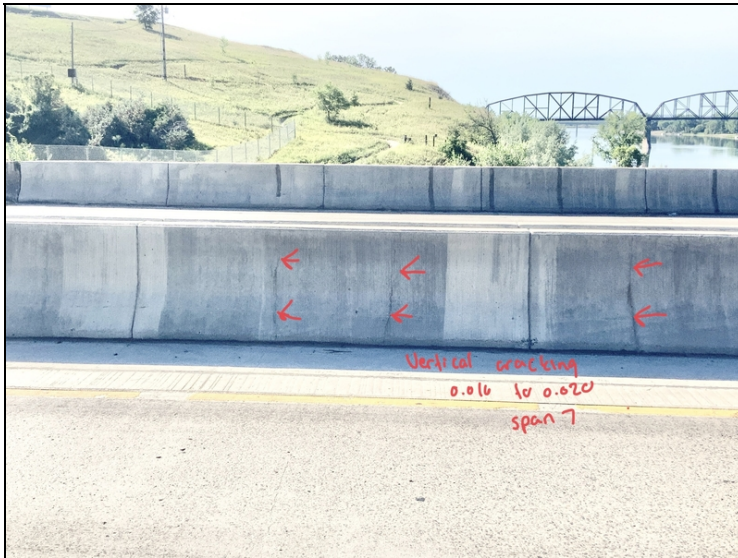
Facing South. Vertical Unsealed cracks to South Barrier in Span 7.

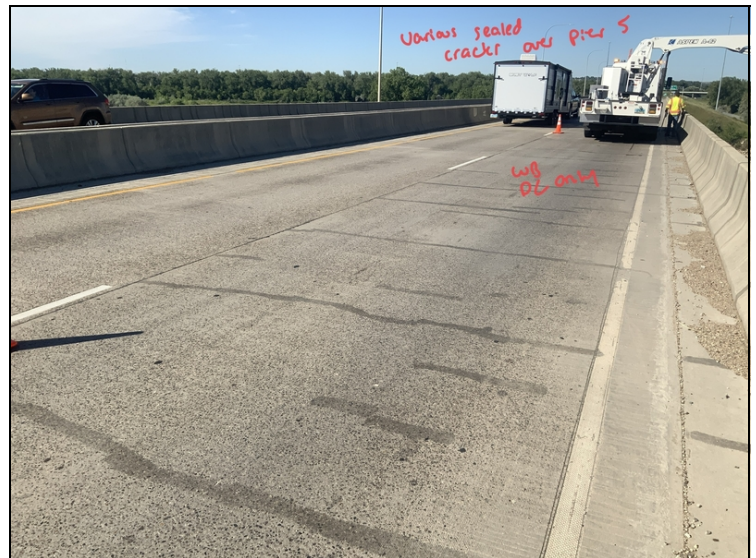
Facing SW. General View of Sealed cracks to WB DL only over Pier 5. WB PL Cracks unsealed.

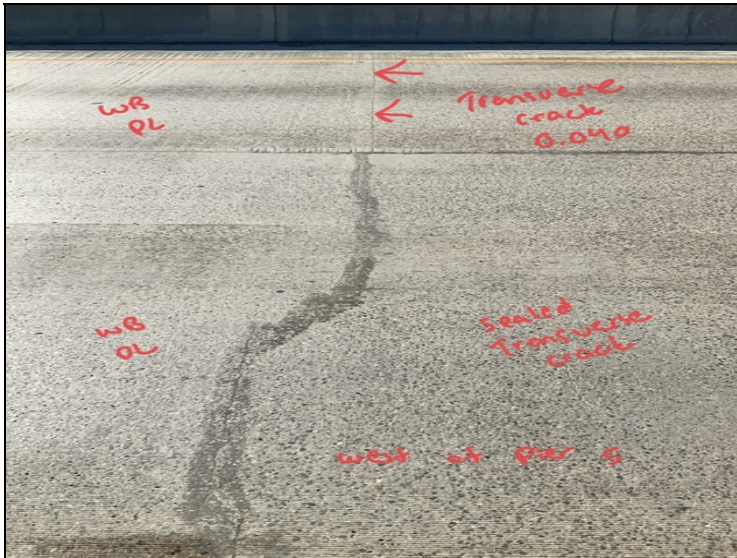
Facing South. Transverse crack sealed in the WB DL and unsealed in the WB PL West of Pier 5

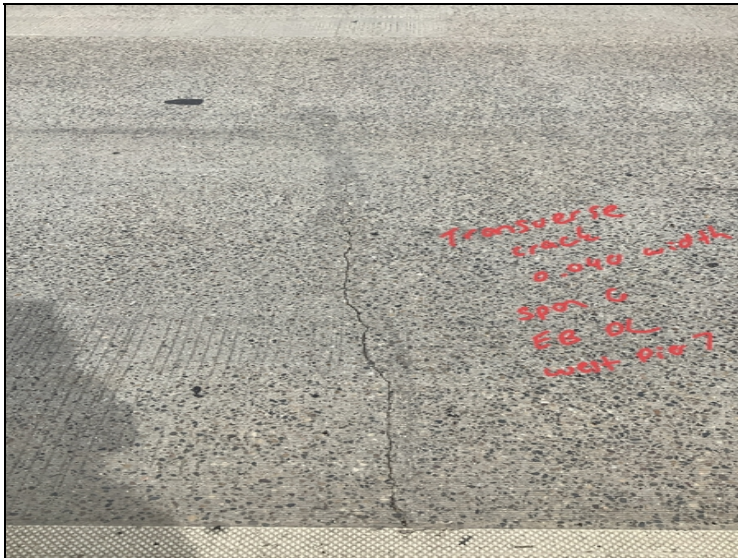
Facing North and Downward. Transverse cracking to EB DL West of Pier 7.

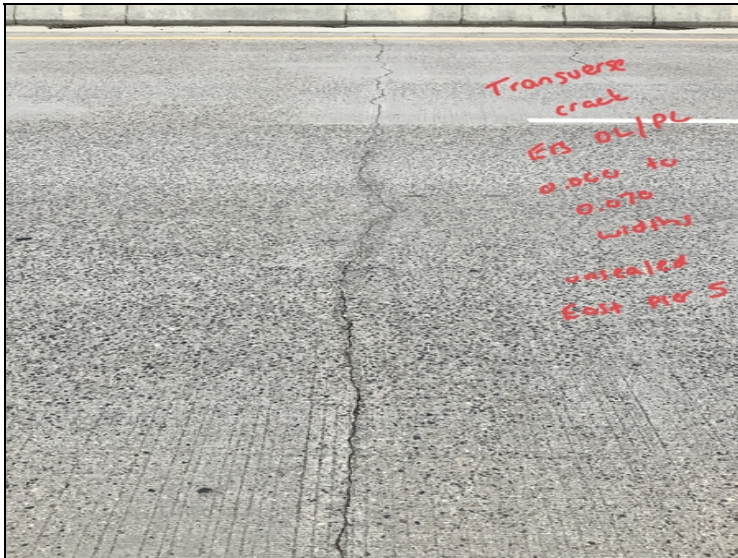
Facing North and Downward. Transverse cracking to EB PL East of Pier 4.

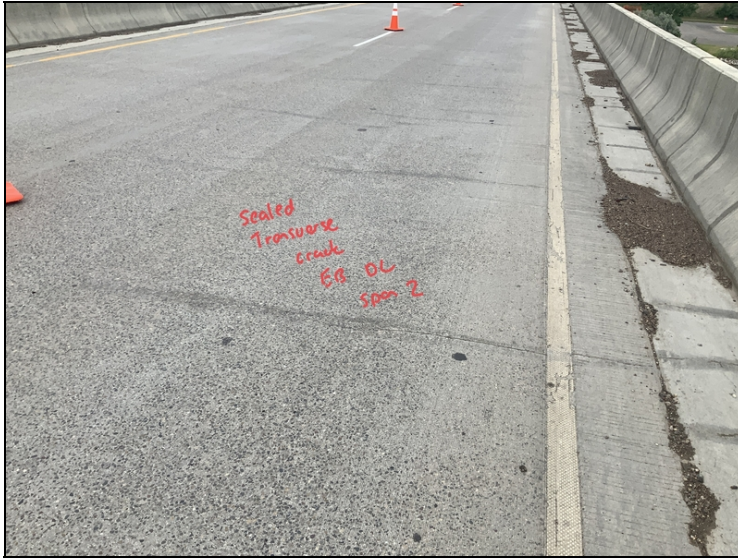
Facing NE and Downward. Various Transverse cracks to EB I-94 DL sealed. Some sealant showing wear.

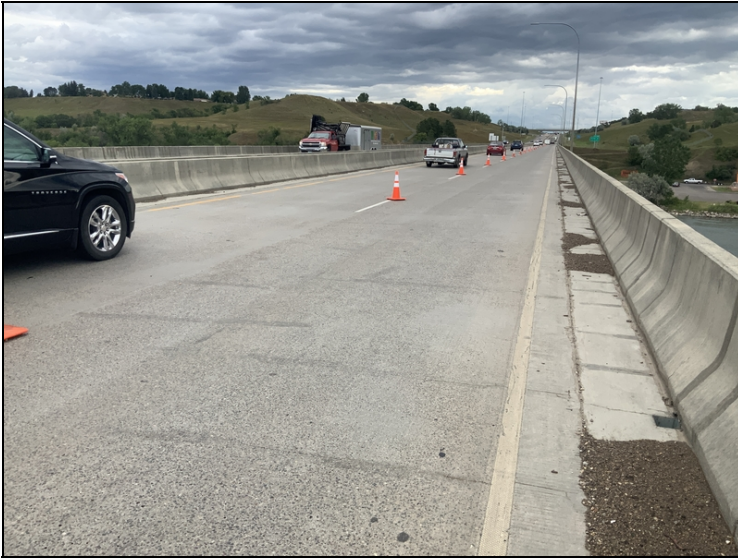
Facing NE. General view of Wearing Surface.  
Some DL Cracks sealed. All PL Cracks unsealed.

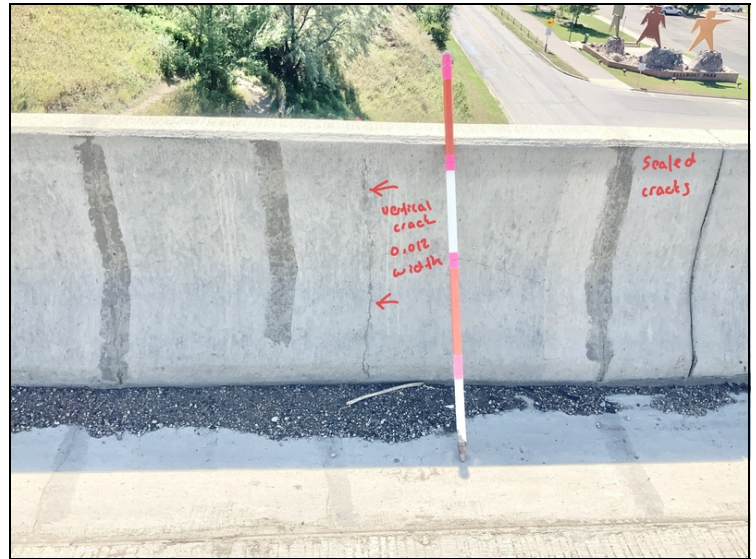
Facing South. Vertical cracking sealed and  
unsealed to EB DL Bsrrier in Span 7.

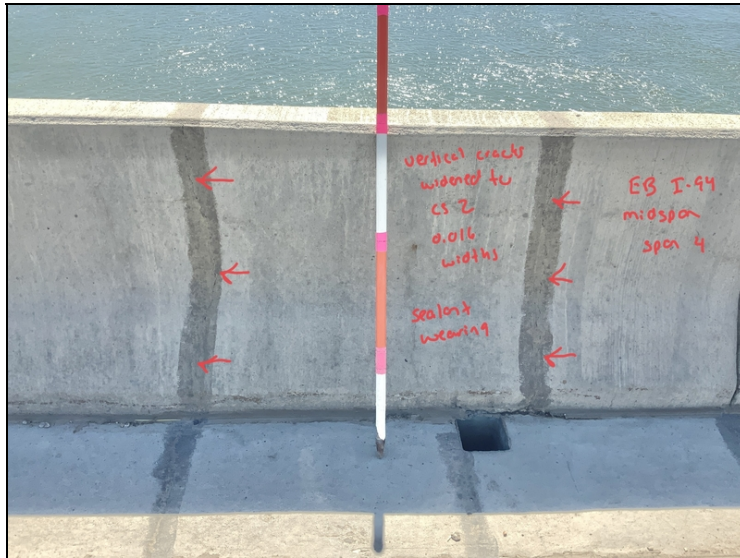
Facing South. Various vertical seal and unsealed cracking to EB DL Barrier in Span 4.

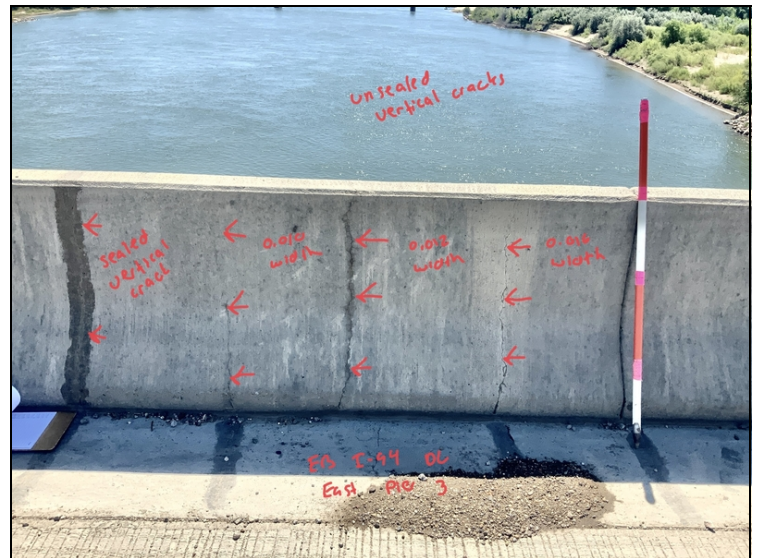
Facing South. Various vertical sealed and unsealed cracks to EB DL South Barrier in Span 3.

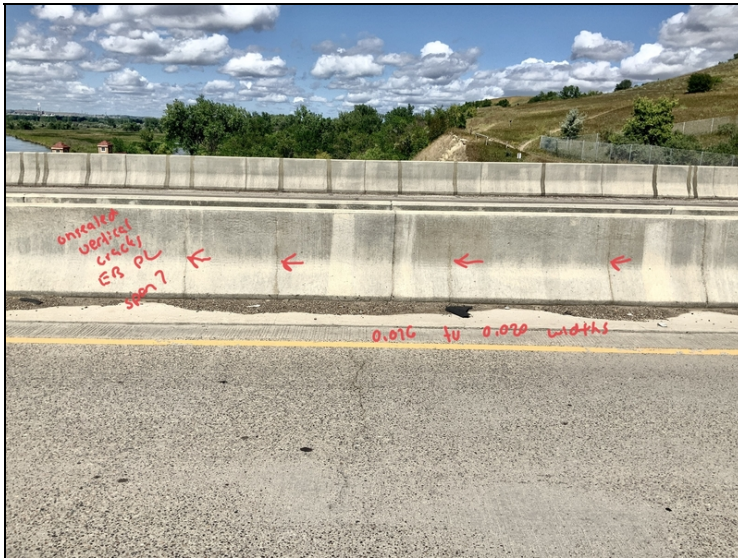
Facing North. Various vertical unsealed cracks to EB PL North Barrier in Span 7.

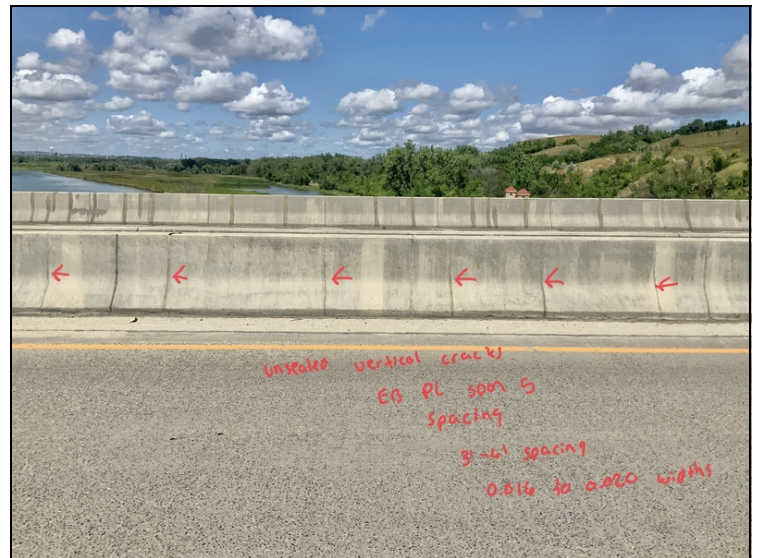
Facing North. Various unsealed vertical cracks to EB PL North Barrier in Span 5.

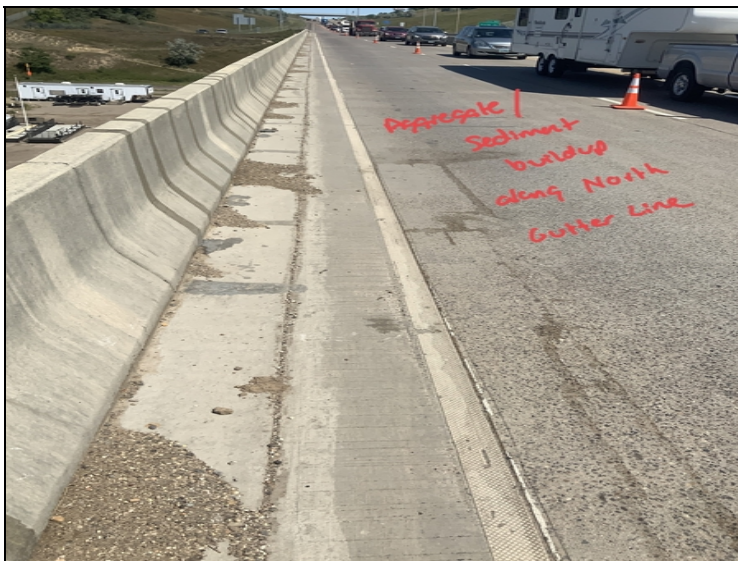
Facing East and Downward. Sediment and Aggregate Buildup along North Gutter Line of WB 1094.

Recommendation to flush Gutter Lines. Pier 2 and Pier 6 with debris filling up in both Expansion Joints. Recommendation to Flush out the Joints. Recommendation to clean out drainage systems. Sediment and Aggregate Buildup along WB and EB DL Gutter Lines.

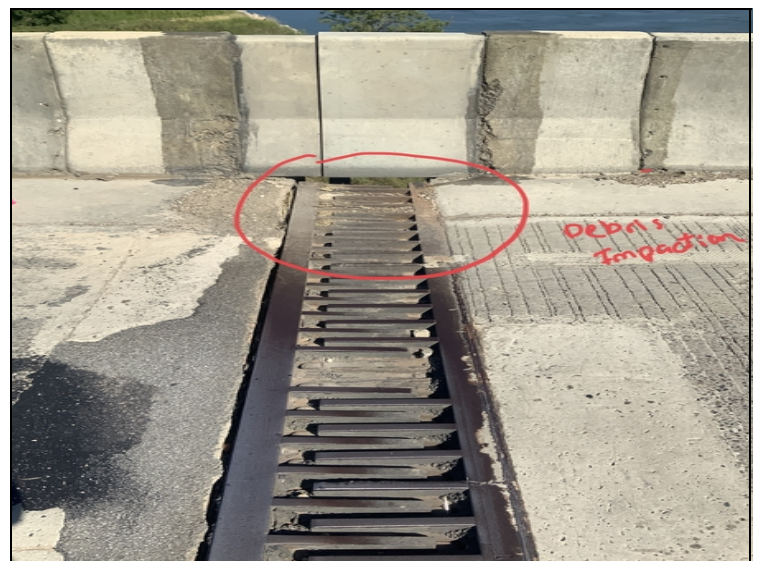
Facing North and Downward. Debris Impact to Gutter Line of Expansion Joint over Pier 2.

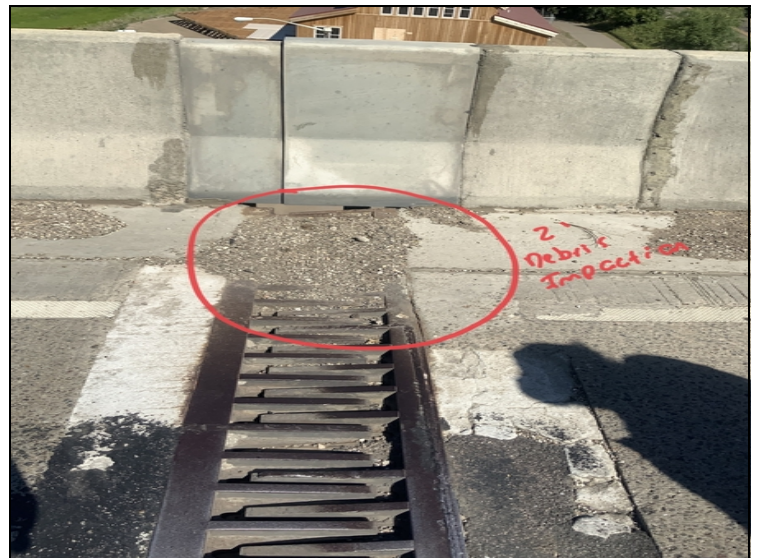
Facing North. Debris Impaction along Gutter Line of WB DL at Pier 6 Expansion Joint.

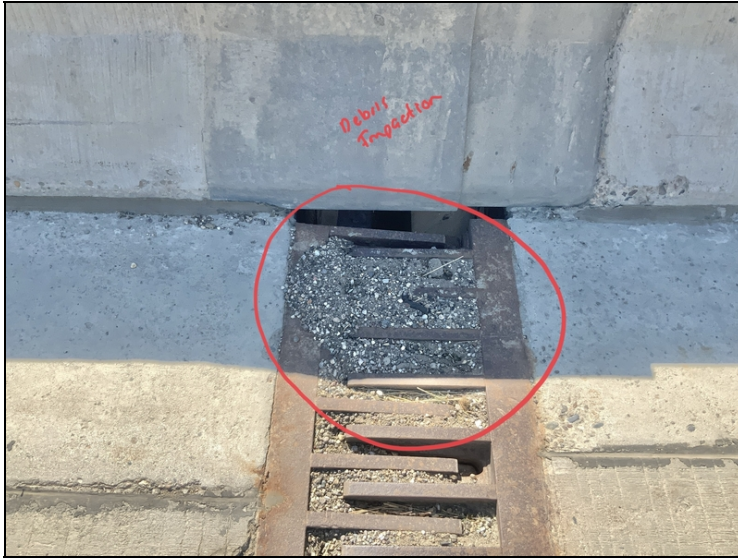
Facing South and Downward. Debris Impaction to South end of Pier 6 Joint Gutter Line of the WB PL.

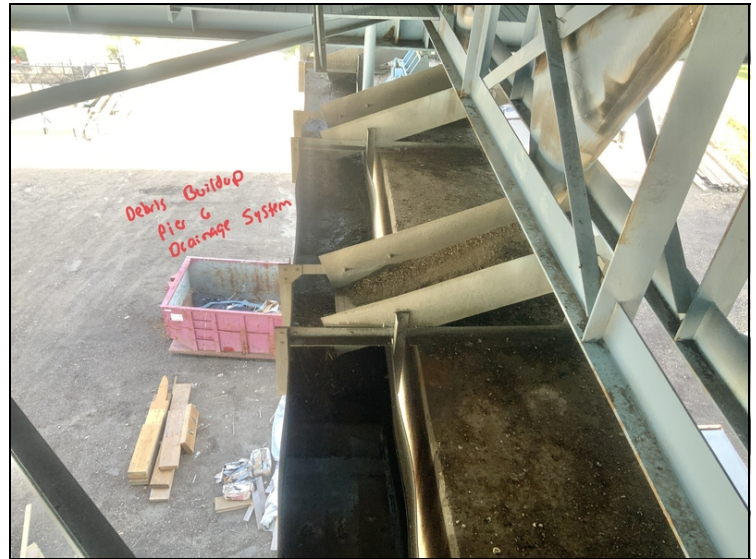
Facing North and Downward. General View of Pier 6 drainage system with sediment and debris buildup restricting flow.

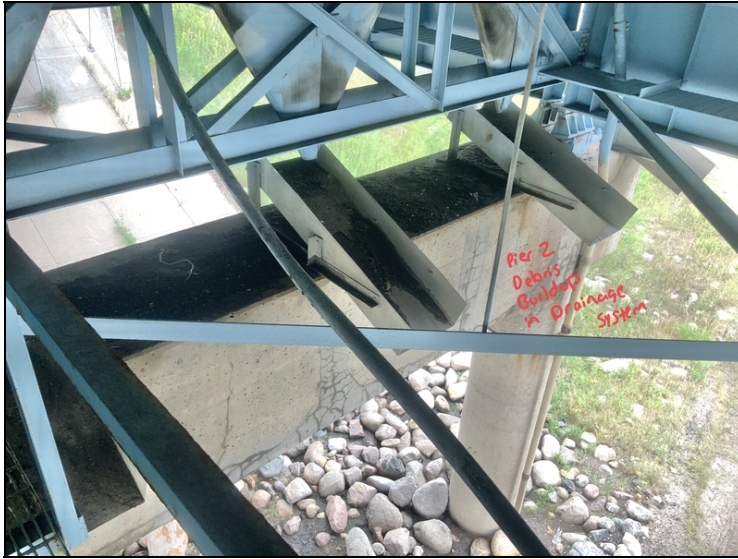
Facing NW and Downward. Pier 2 Drainage System WB I-94 with Debris and Sediment Buildup in troughs.

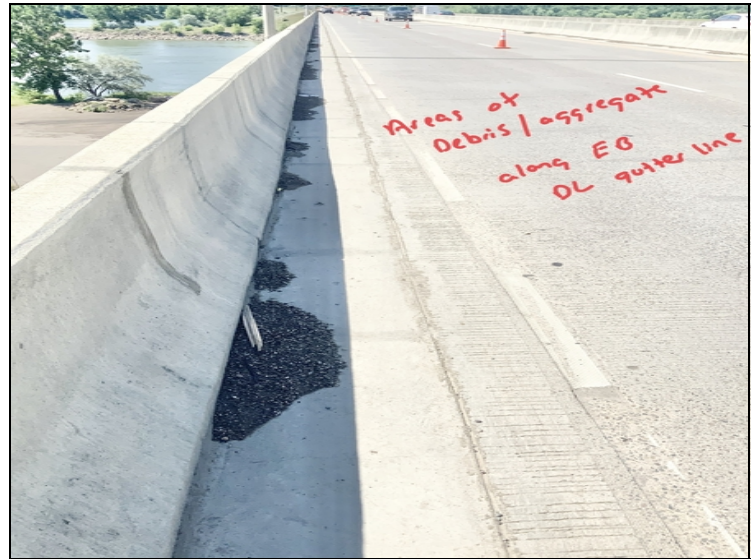
Facing West and Downward. Areas of sediment and aggregate buildup along EB DL Deck Extension Gutter Line.
